Circular 196-AN/119

AIRCRAFT ACCIDENT DIGEST 1983 (No. 30)

On January 11, 1983, United Airlines Flight 2885, a McDonnell Douglas DC-8-54F, N8053U, was being operated as a regularly scheduled cargo flight from Cleveland, Ohio, to Los Angeles, California, with an en route stop at Detroit, Michigan. United 2885 departed Cleveland at 0115 and arrived at the Detroit Metropolitan Wayne County Airport at 0152, where cargo for Detroit was unloaded, the airplane was refueled, and cargo for Los Angeles was loaded. At 0249:58, United 2885 called for clearance onto runway 21R and was cleared for takeoff at 0250:03. Visual meteorological conditions prevailed at the time, and the company had filed and been cleared for a standard IFR flight plan.

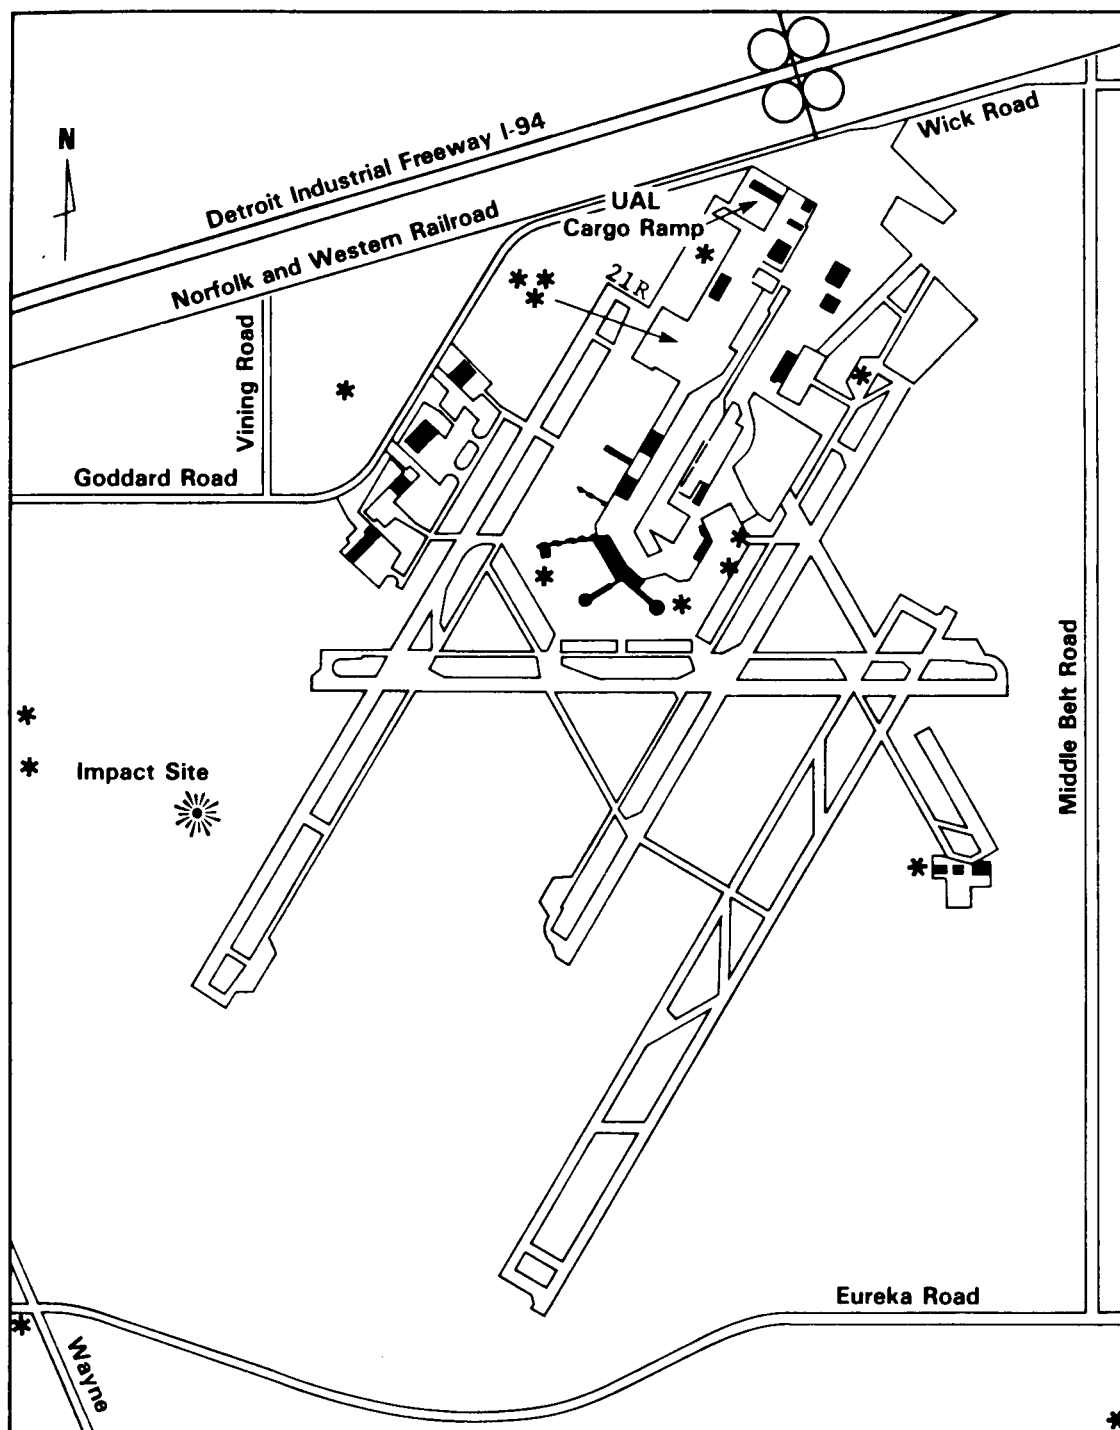
Figure 1.--Detroit Metropolitan Wayne County Airport runway/terminal layout, accident site, and witness locations.

According to the witnesses, approximately 5 seconds after the takeoff and as the airplane was climbing, flames could be seen behind the engines on both wings. Witnesses described the flames variously as coming from one, two, or three of the engines; as coming in two short bursts and then ceasing; as looking like "sparks;" and as looking like a "fireworks show which lit up the sky." According to most witnesses, the airplane continued to climb with wings level to about 1,000 feet. The airplane then rolled to the right in a gradual right turn until it was in a wings vertical position (right wing down, left wing up). One witness, who was located 1 mile east of the takeoff point, thought the angle of ascent was normal and that the airplane banked to the right about 30° from the horizontal and never increased above that angle. Another witness, who was located 1,000 feet beyond the end of runway 21R, stated that the airplane started a sharp right turn at 300 to 500 feet. Most witnesses could not recall the attitude of the airplane from the time it reached the wings vertical position until it crashed, and simply said that the airplane "dropped from the sky" at that point. Two witnesses who had head-on views reported that the airplane came back to a wings horizontal (nose slightly down) attitude from the wings vertical attitude just before the crash. When queried about whether they could have been looking at the airplane in an inverted horizontal position at this point, these two witnesses said they were not positive. They could not recall the position of any of the airplane's external lights when it was in the horizontal position. All of the witnesses stated they saw an explosion which was followed by a fireball and intense ground fire.
